City of Key Colony Beach

Seawall Owner's Manual

Prepared By:
City of Key Colony
Building Department

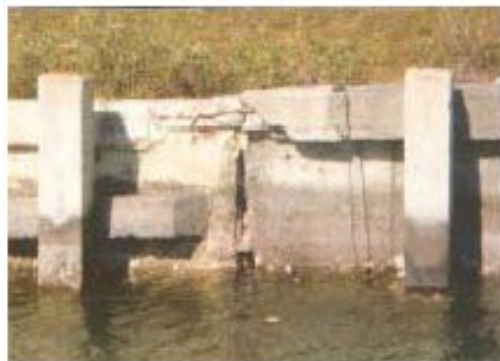
The canal side of the same seawall shows a wide separation between slabs. More backfill is washed away from the fill side daily as the tide flows in & out through the separation.

Cause: Age, settling, structural failure or perhaps insufficient berm at the slab toe of the wall. Slabs move apart vertically and horizontally, allowing backfill to migrate through the openings into the water, and salt water to enter behind the wall. Uneven hydrostatic pressure is exerted on the slabs, particularly at low tide. This may be critical during heavy rain and low tide conditions.

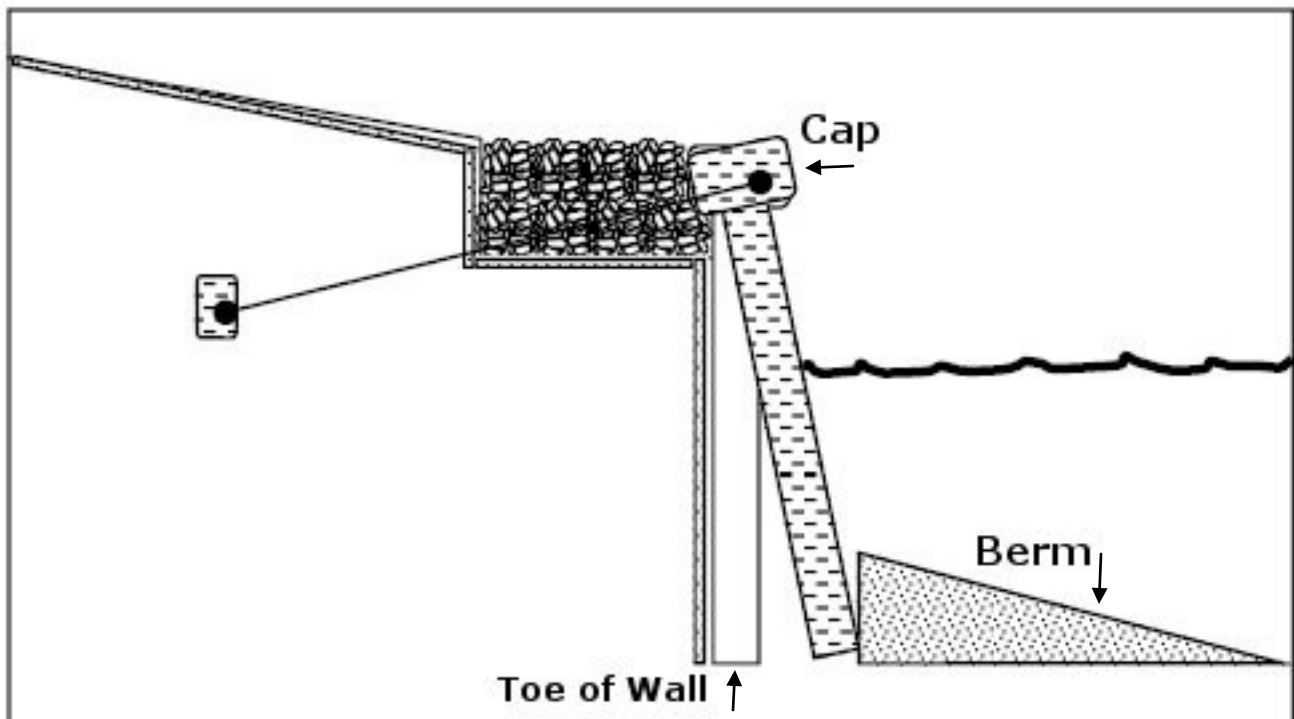
BERM FAILURE

Cause: Loss of supporting berm at the bottom of the slabs in the water. The panels tilt out, and sometimes crack or cause the cap to twist or break. Loss of berm is usually associated with wave action, either natural or from speeding boats. Improper berm placement may be the cause of such failures.

Symptoms: Cap rotation, movement or cracking, a gap opening between seawall and dock (if present), and support pilings (if present) tight against the seawall indicating pressure on the structure from the failure. A good way to determine berm loss is to measure the height of the wall from the cap to the berm. Most panels or slabs are 10 feet in length, so that less than 2 or 3 feet of berm holding them in place may be the reason for existing toe-out or future toe-out.

Remedies: Placement of additional berm, rip-rap or bags of dry concrete mix to stabilize the bottom of the structure if the toe-out is not too severe. In bad cases, the panels may be pulled and replaced, or reinserted if not badly damaged. If pilings are present along the seawall perimeter, or dry concrete bags inserted between them and the wall may help. Repairs to the cap will depend on the amount of damage.

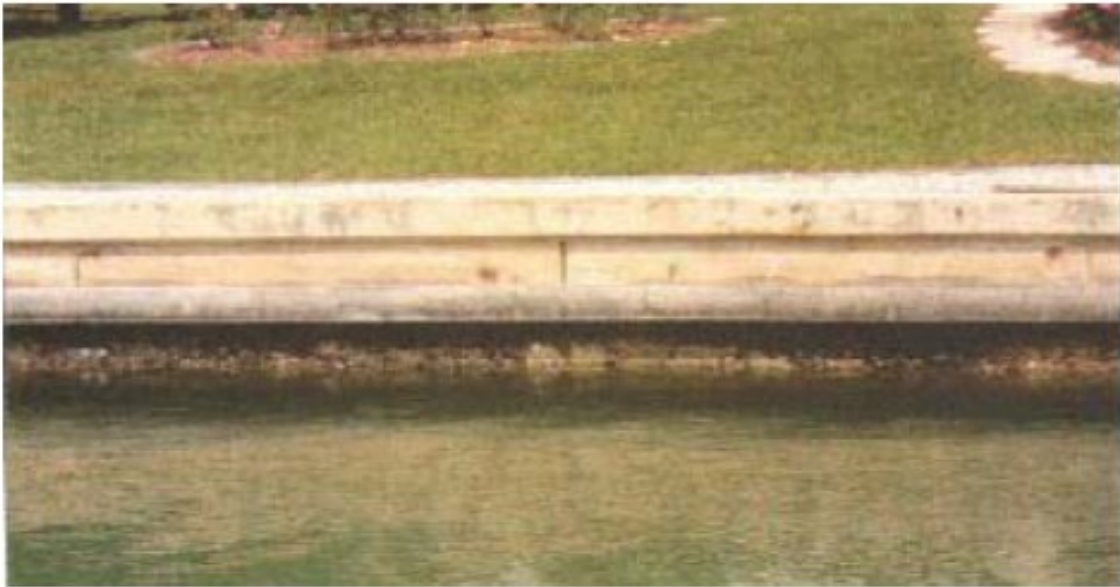
A waler is installed about 2 ft. below the seawall cap. The waler is a reinforced concrete beam which is connected to tie-back rods anchored to deadman. A waler is usually added as reinforcement when it is suspected the original tie-back rods to the cap have rusted through.

A supporting structure installed about 2' below the seawall top placed on the outside of the panels which normally anchors a separate tie-back rod system to help support the seawall.

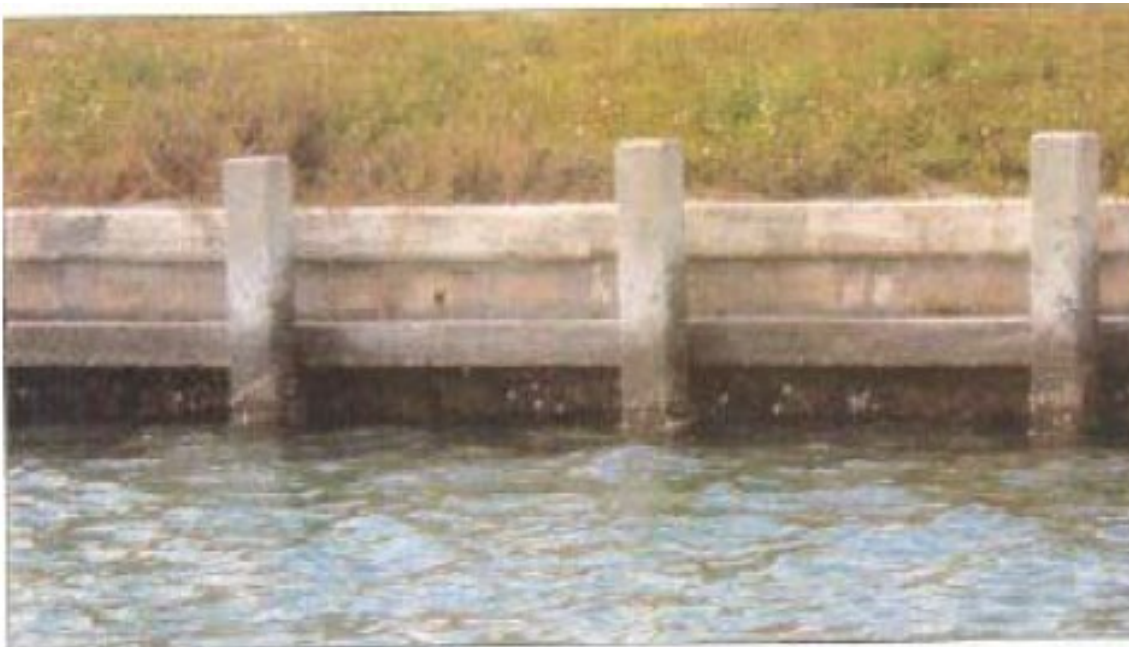
This seawall has a waler plus pilings driven into the canal bottom for extra support. The pilings help stabilize the wall to keep the toe of the wall from moving out.
